Camas Creek Subbasin Five-Year Review

HUC 17040220

**State of Idaho
Department of Environmental Quality**

December 2016

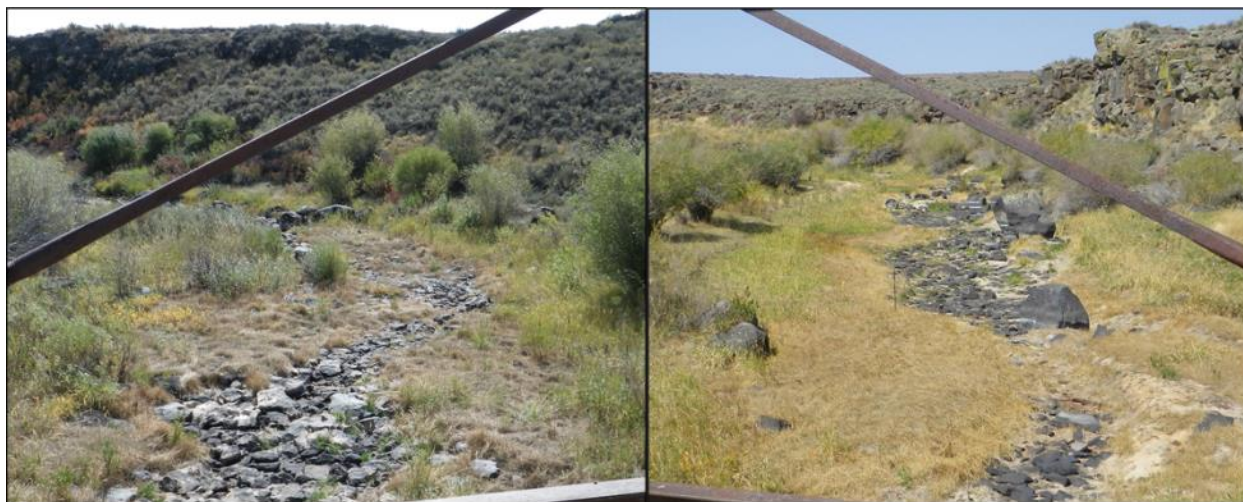
- 5th-order flows are in direct response to spring runoff and significant precipitation events that occur in the Willow Creek catchment area.
- During low flows, the 5th-order channel of Camas Creek upstream of Willow Creek is dry (Figure 3).

Figure 3. Camas Creek assessment unit ID17040220SK001_05; dry channel at Macon Flat Road, 9/9/2014.

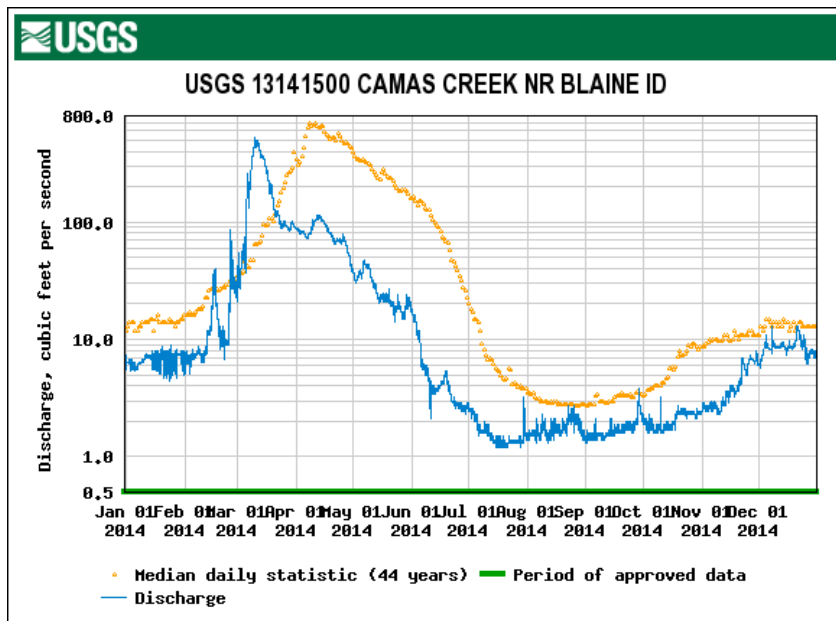
Figure 4. Camas Creek annual median/2014 daily hydrograph.

Flows for 2014 were consistently lower than the historical average, and the peak spring-melt runoff occurred earlier than normal. Late-summer flow measured at this location is directly influenced by Willow Creek discharge, as the upstream Camas Creek channel is dry up. Further discussion of this influence can be found in the flow narrative for US-3 (Willow Creek).

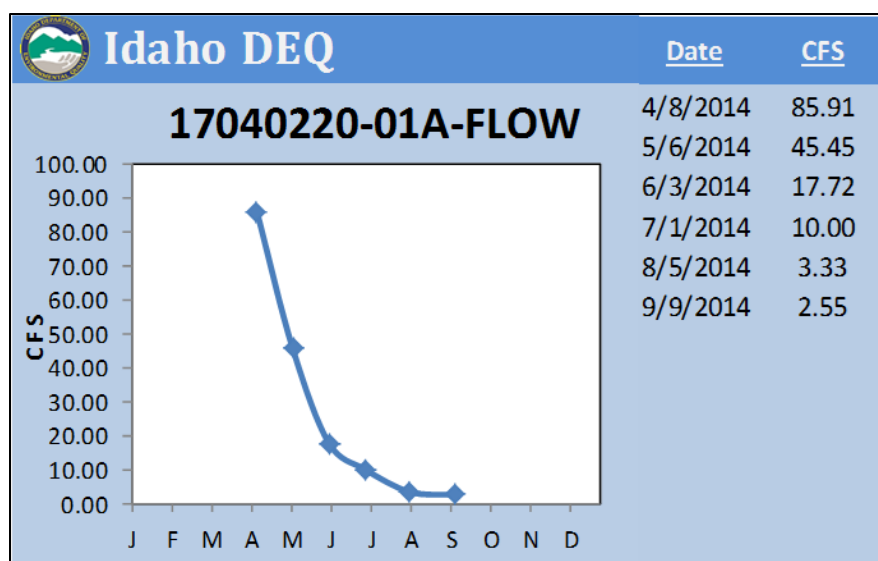
Additional flow measurements were captured during 2014 sampling events at sampling site 17040220-01A (Figure 5). These measurements were consistent with flows seen at the USGS gage located at 17040220-01B.

Figure 5. Flows at site 17040220-01A, 2014.

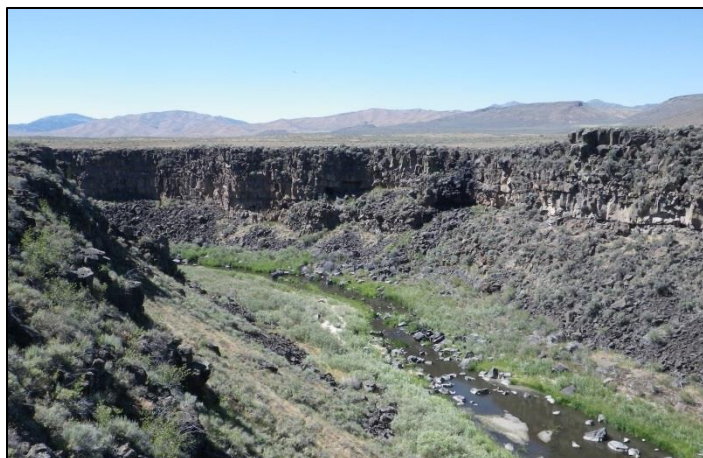
Figure 8. Camas Creek canyon.

Bank stability inventories were performed visually on the 5th-order of Camas Creek at locations that offered reasonable and safe access. Visual observation showed that cliffs and boulders that comprise the riparian zone physically restrict anthropogenic uses that would contribute to unstable banks (Figure 8). Bank instability at these locations is likely to be natural and result from fluvial influences.

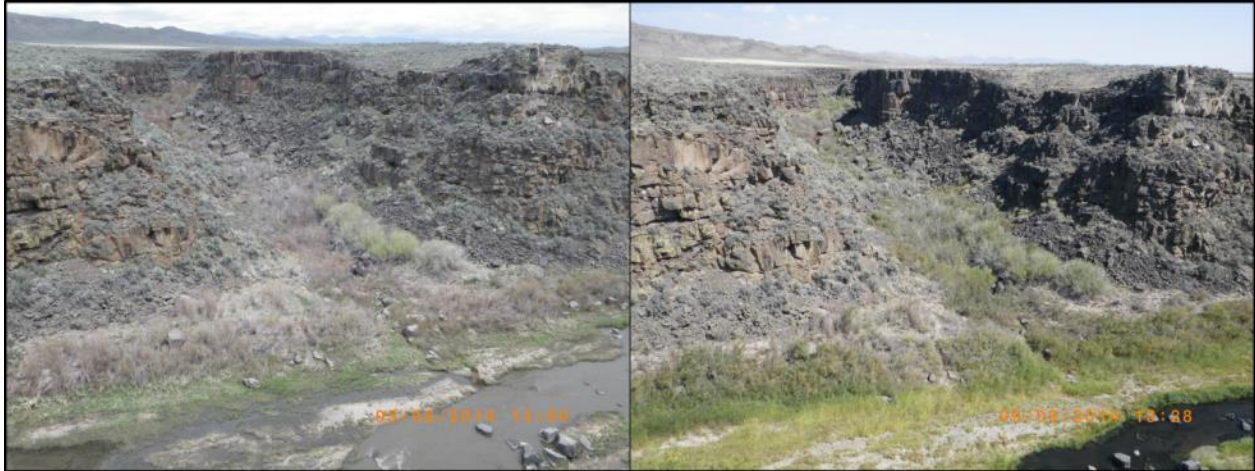
- 3rd-order flows measured at 17040220-02A (Figure 11) were in direct response to spring runoff. During periods of precipitation runoff flashing in late summer 2014, no discharges from Camp Creek into Camas Creek were obvious, confirming ephemeral flow regime.

Figure 11. Sample site 17040220-02A: Camp Creek confluence into Camas Creek, May and September 2014.

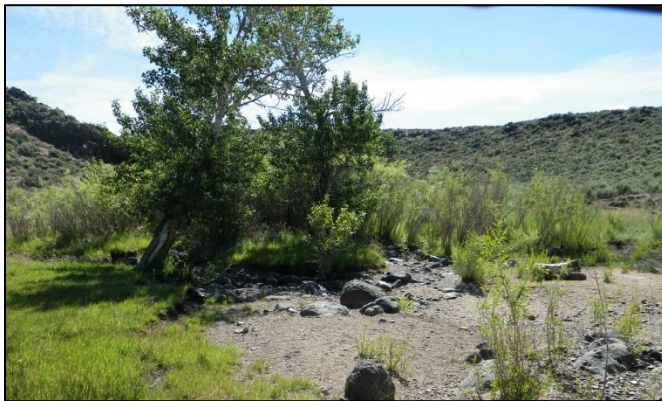
Figure 12. Camp Creek assessment unit ID17040220SK002_02; dry channel, 6/19/2014.

- The lower reaches of the 2nd-order of Camp Creek (adjacent to Camp Creek Road) lose their spring-runoff flow in early summer (Figure 12).

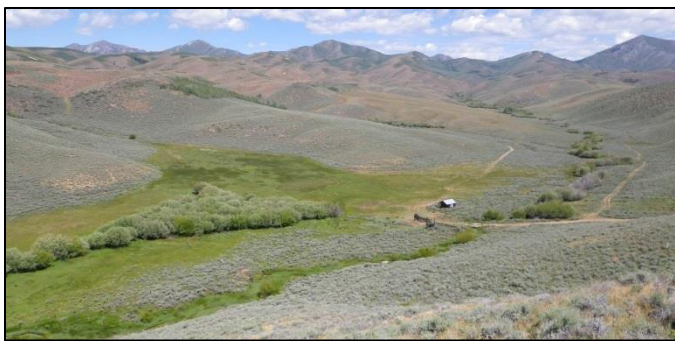
Figure 13. Camp Creek assessment unit ID17040220SK002_02 upstream of the beaver complex, 6/19/2014.

- All tributaries of Camp Creek are ephemeral and respond only to spring runoff and precipitation.
- A beaver complex exists in the ID17040220SK002_02 Camp Creek canyon, upstream of the divergence of the Camp Creek Road. This complex exists entirely on BLM property and appears to be stable and functioning.
- Upstream of the beaver complex, the Camp Creek channel is moderately incised through a historic meadow complex (Figure 13). Walking bank surveys in 2014 revealed that the channel is currently stable and is possibly aggrading in a few locations.

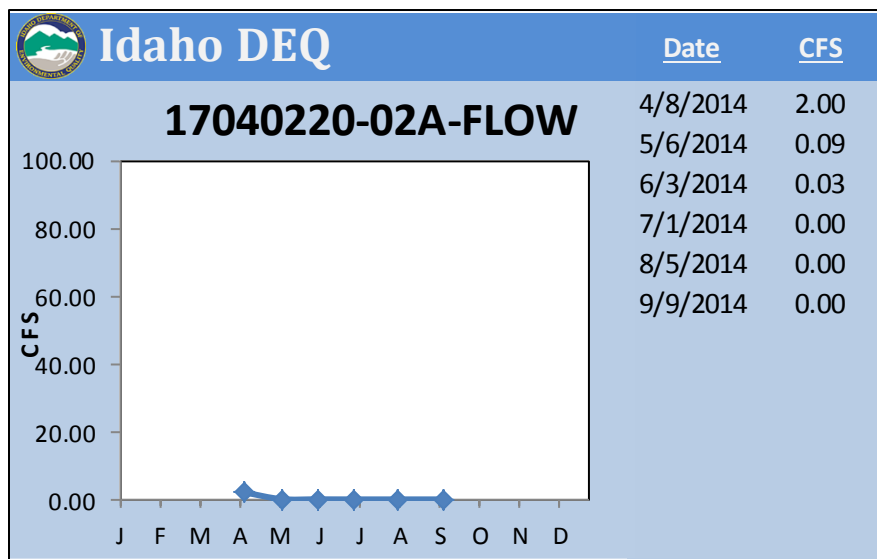
A dry channel was observed during site visits in July, August, and September. Field inspections upstream confirmed that channel flows had subsided and that all tributaries in the watershed are ephemeral.

Figure 14. Flows at 17040220-02A, 2014.

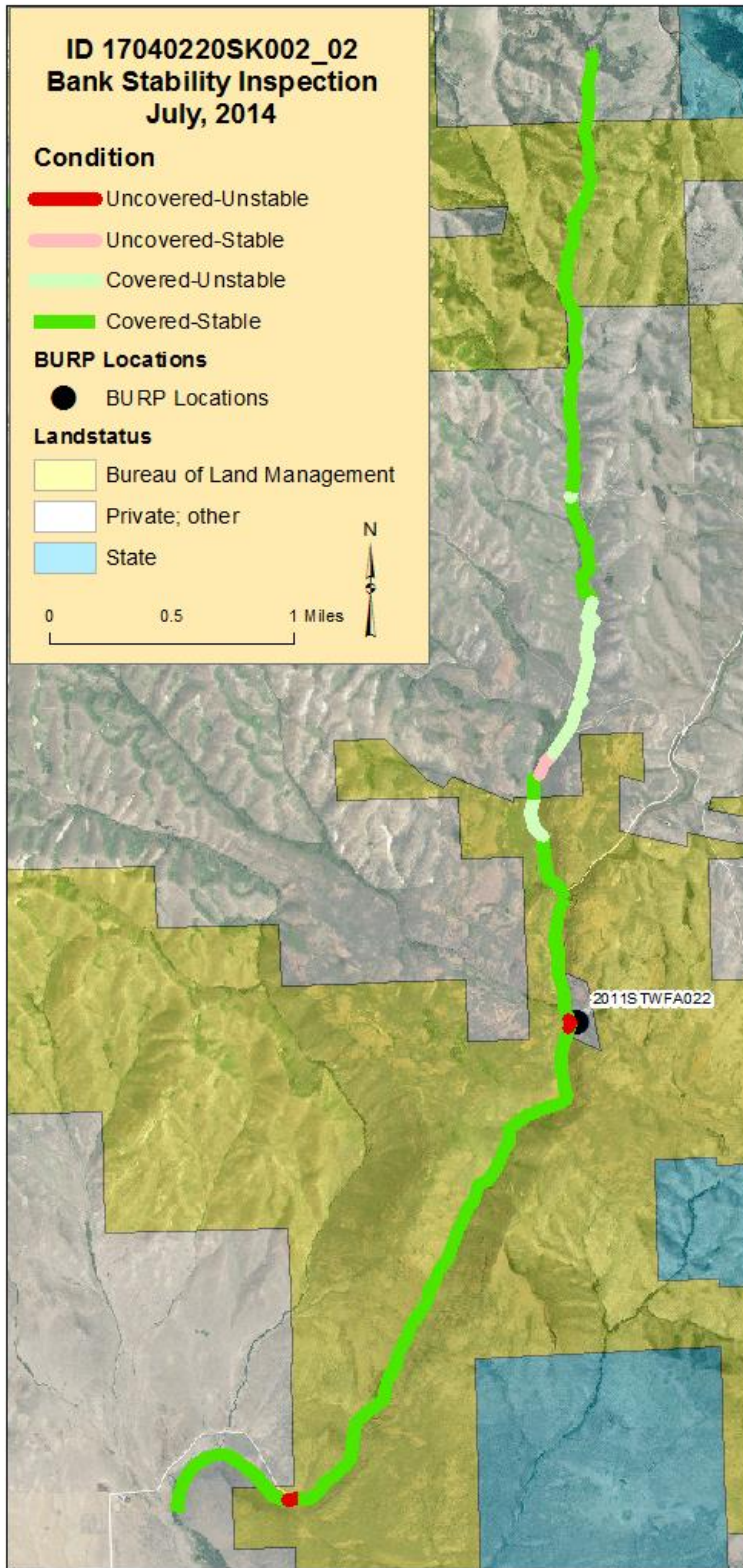
A georeferenced bank stability inspection was performed during two days in July 2014. The resulting line features and associated conditions are displayed in Figure 16.

Figure 16. Bank stability inspection for Camp Creek.

The predominant condition of the inspected channel of Camp Creek is “covered-stable.” The most compromised section of Camp Creek in this AU occurs on the private land between the BLM parcels, in the historic meadow complex. This degraded reach is likely due to historic grazing impacts, and the “covered-unstable” condition is a probable indication of an incised channel with caving banks (Figure 17).

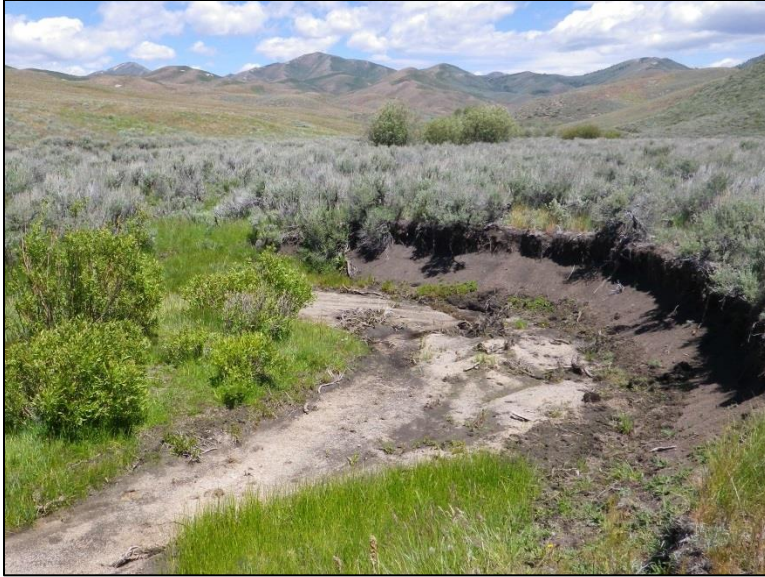
Figure 17. Camp Creek "covered-unstable" banks.

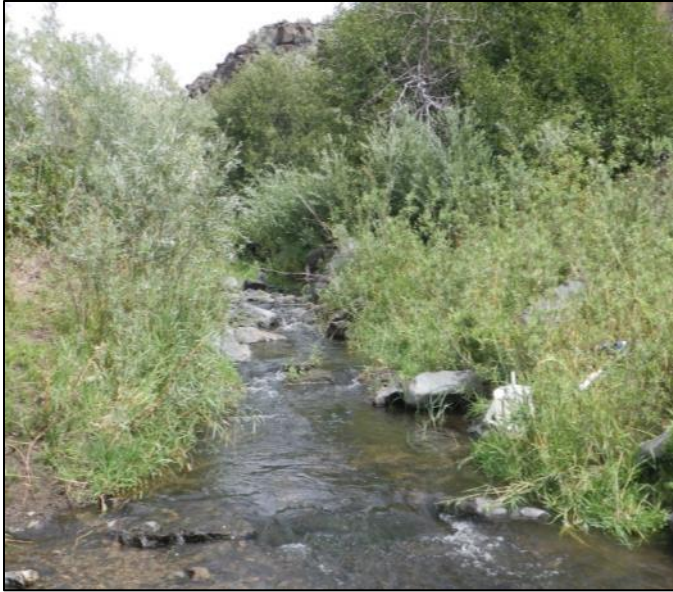
1. All stream segments comprising AU ID17040220SK003_02 are ephemeral.
2. The entire length (9.36 miles) of AU ID17040220SK003_04 is perennial (Figure 20).
3. ID17040220SK003_04 loses flow throughout the central portion of the reach, and then regains most of this flow near the mouth. This loss may be natural, or a result of an unknown diversion.
4. During snowpack runoff and precipitation events, significant sedimentation and sediment conveyance was observed as a result of Beaver Creek Complex Fire erosion.
5. An active beaver pond complex exists at the abandoned crossing at Lanman Road.

Figure 20. Sample site 17040220-03A on ID17040220SK003_04.

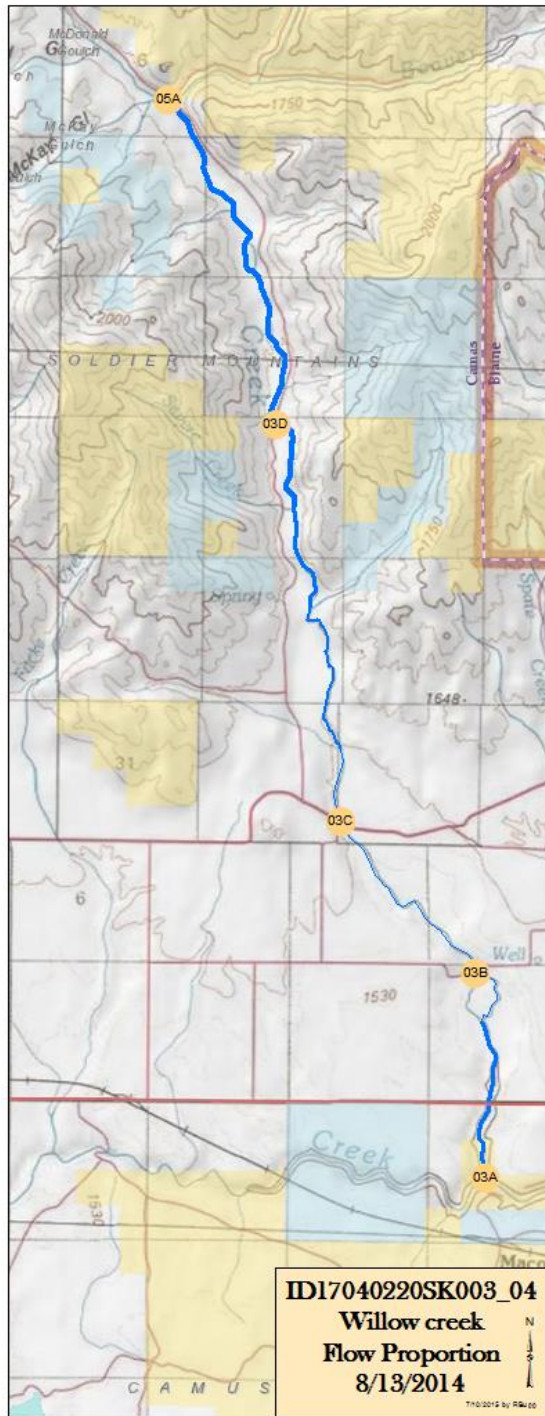
<u>Site</u>	<u>Flow</u>
05A	2.732
03D	3.100
03C	0.233
03B	bvr pond
03A	1.967

Figure 22. Proportional flow for assessment unit ID17040220SK003_04, 8/13/2014.

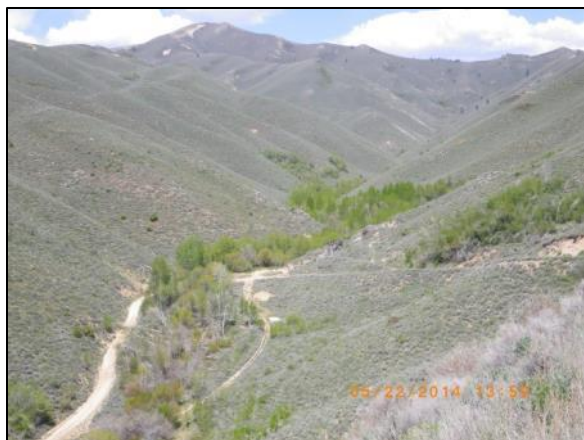
Figure 26. Mine-road crossing of Little Beaver Creek.

5. Little Beaver Creek in ID17040220SK004_02 was experiencing debris flows and channel restructuring throughout spring and summer 2014.
6. The Princess Blue Ribbon Mine is within the drainage area of AU ID17040220SK004_02. Instream effects from historic operation of this mine are restricted to the road crossing culvert area and abandoned pond on Little Beaver Creek (Figure 26). Current conditions appear to be historically degraded but stable as a result of active beaver ponding.

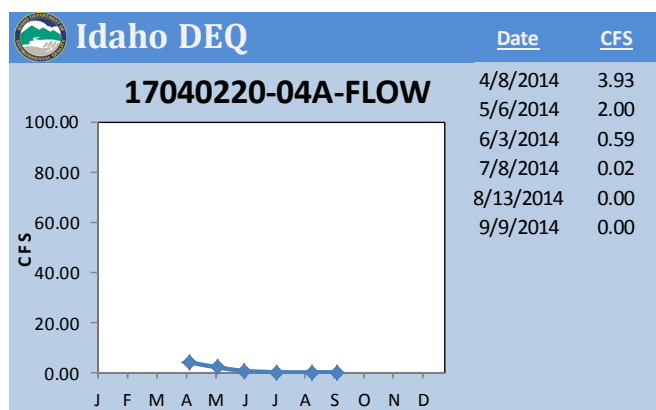
Flows were collected for Beaver Creek at sampling location 17040220-04A, 50 meters upstream of the confluence with Willow Creek. April and May provided the only measurements of significant discharge at 3.93 cfs and 2.00 cfs, respectively. Subsequent measurements in June and July required the use of a small portable V-notch flume to determine trace flows of 0.59 and 0.02 cfs (Figure 27). This sampling location was dry in August and September.

Figure 27. Flows at 17040220-04A, 2014.

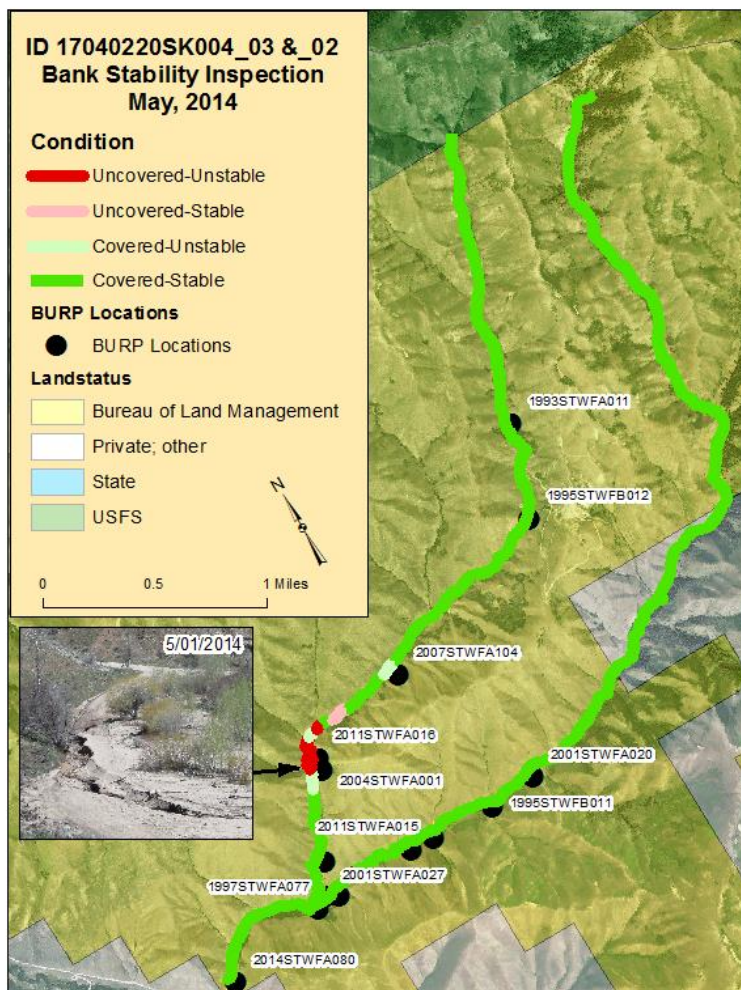
Walking bank stability inventories were performed for this water body in May 2014 (Figure 29). Problematic areas were identified on Little Beaver Creek, apparently a direct result of post-fire mass wasting events.

Figure 29. Beaver Creek (US-4) bank stability inventory.

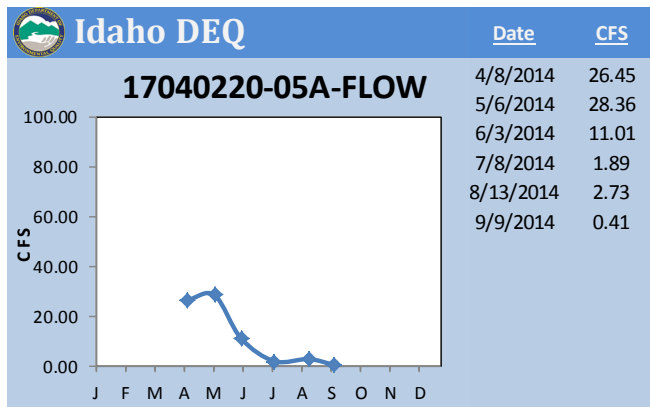
Flows were collected for Willow Creek at sampling location 17040220-05A, 50 meters upstream of the confluence with Beaver Creek. April, May, and June provided the most significant discharges, each measurement exceeding 10 cfs. Regular flows in subsequent months appear to be less than 2 cfs. The flow bump measured in August (2.73 cfs) was in direct response to heavy rainfall (Figure 32).

Figure 32. Flows at 17040220-05A, 2014.

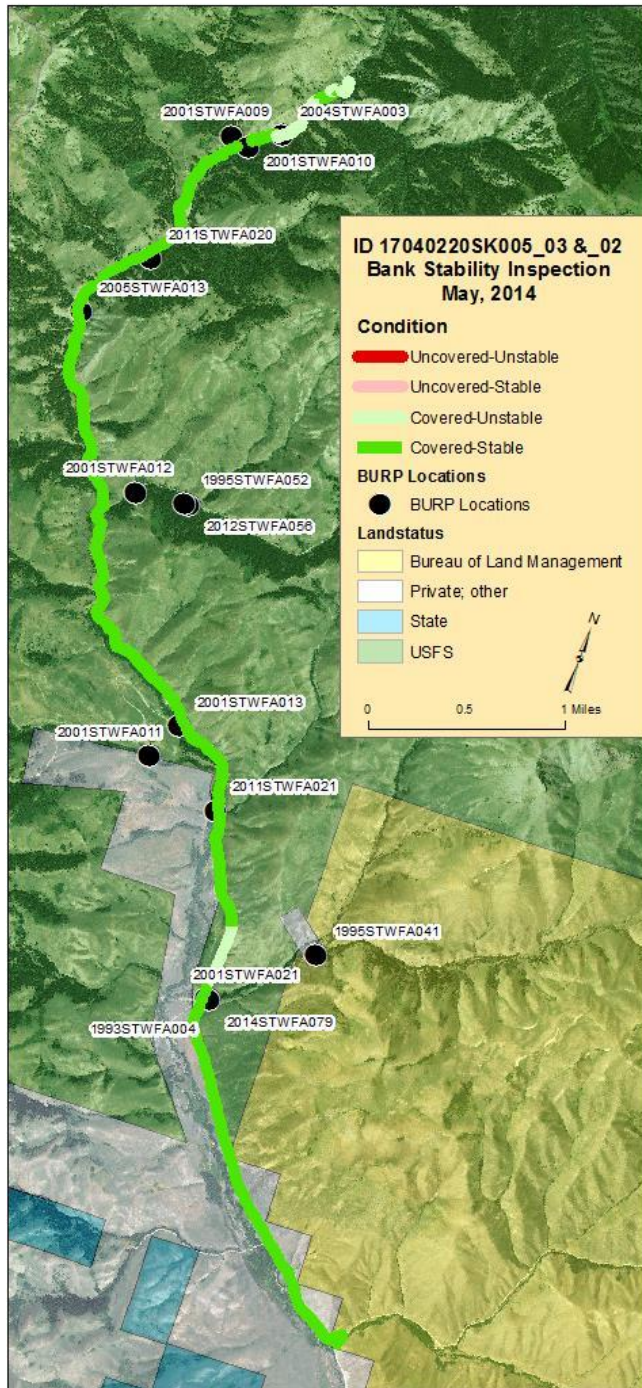
A bank stability inspection was performed for this water body in May 2014 (Figure 34). Very few vulnerable areas were identified on Willow Creek. The covered-unstable reach just upstream of Cherry Creek appeared to be a result of beaver dam failure, and the areas upstream of West Fork Willow Creek are experiencing deposition from the Beaver Complex Fire.

Figure 34. Willow Creek (US-5) bank stability inspection.

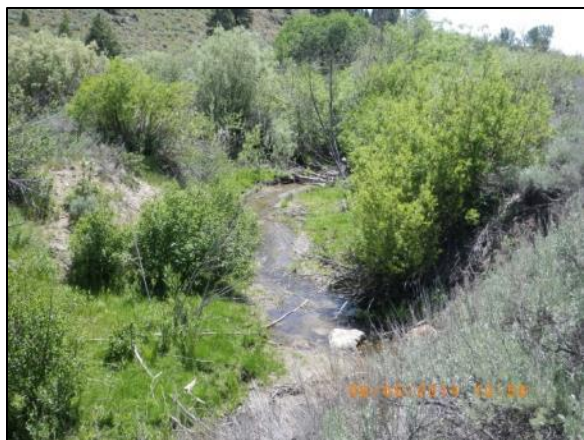
Figure 37. Elk Creek, recovering channel.

1. All stream segments comprising AU ID17040220SK006_02 are ephemeral.
2. Diversion for irrigation occurs immediately downstream of the BLM property near the mouth of the canyon. Diversion commences in May and continues until supplying flow depletes.
3. Diversion occurs in a reach with an active beaver community, with ponds mostly remaining as intact as possible.
4. The walking streambank stability inventory identified historic channel incision upstream of the BLM land. This appears to have mostly stabilized. Existing features observed include point bars, re-established flood plain, and well-rooted willow communities (Figure 37).

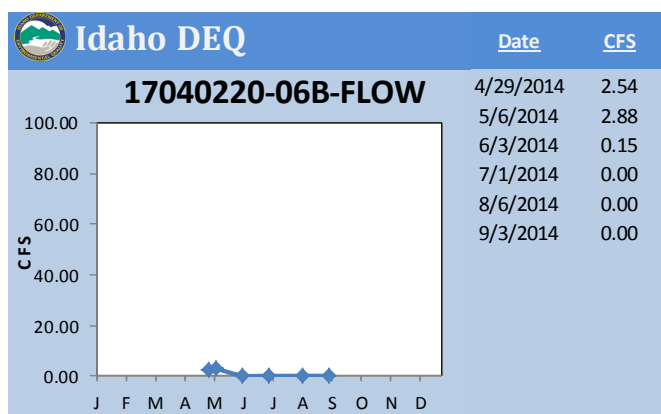
Flows were collected for Elk Creek at sampling location 17040220-06B, at the northern boundary of the Geran property. April and May provided the only measurements of significant discharge at 2.54 cfs and 2.88 cfs, respectively. Subsequent measurement in June required the use of a small portable V-notch flume to determine the flow of 0.15 cfs. This sampling location was dry in July, August, and September (Figure 38).

Figure 38. Flows at 17040220-06B, 2014.

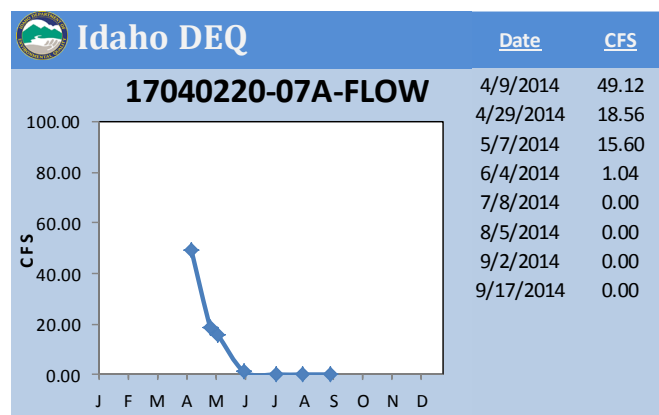
Flows were collected for this reach of Camas Creek at sampling location 17040220-07A, at the bridge upstream of Deer Creek. Flows measured in April and May provided the most significant discharges at 49.12 cfs, 18.56 cfs, and 15.60 cfs. In early June, the instream flow receded significantly to 1.04 cfs. All subsequent visits in July, August, and September yielded a dry channel (Figure 43).

Figure 43. Flows at 17040220-07A, 2014.

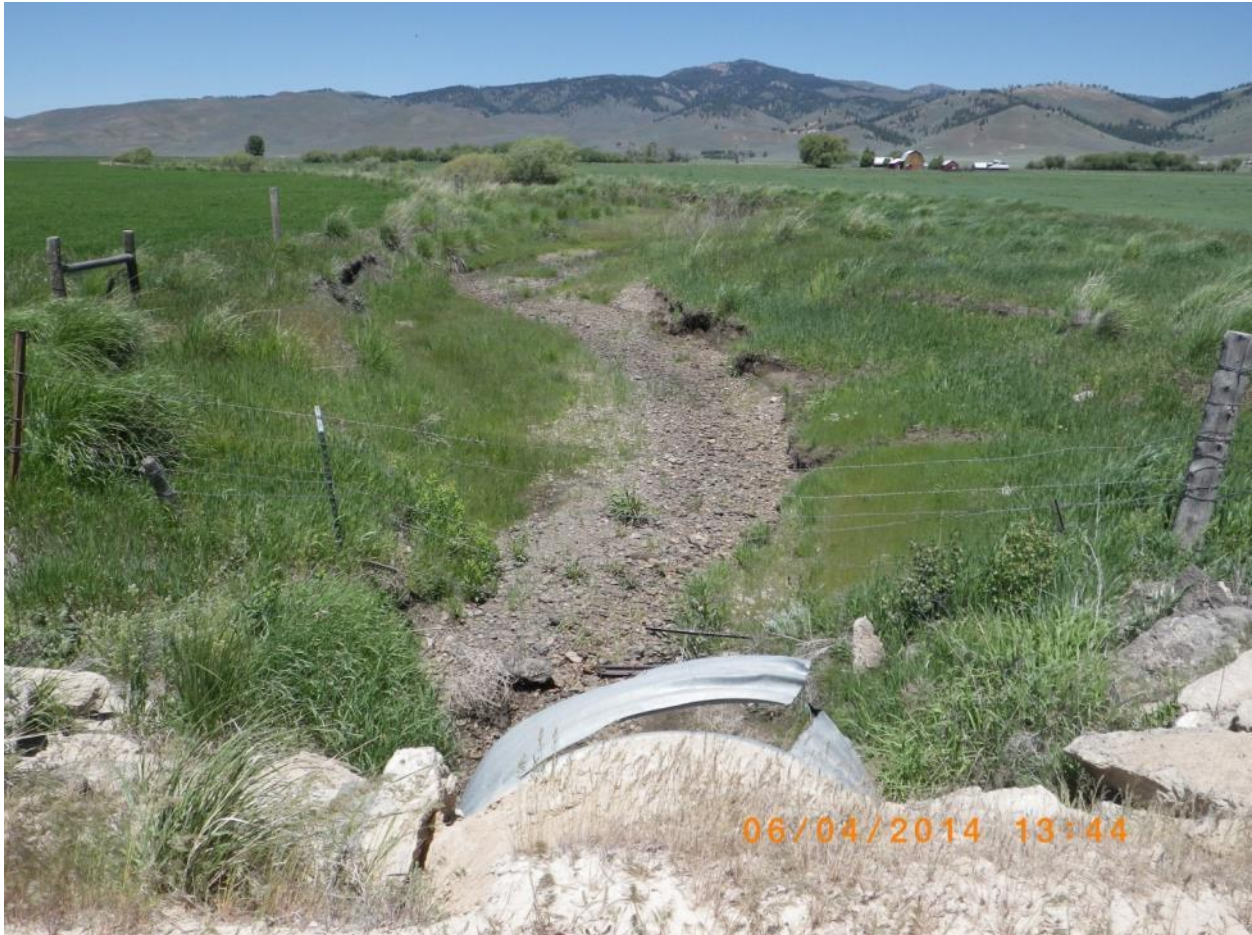
1. All stream segments comprising WBID US-8 are ephemeral (Figure 47).
2. Spring flows are in direct response to snowmelt.
3. The water quality conditions in this water body are currently dictated by the flow regime.

Figure 47. Deer Creek (US-8) 6/04/2014. Ephemeral flow regime in Deer Creek dictates water quality potential.

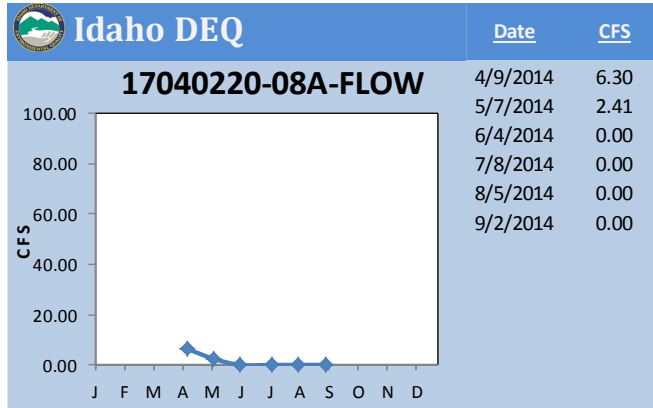
Flows were collected for Deer Creek at sampling location 17040220-08A, above the Bar Ranch Road culvert. April and May provided the only flow measurements at 6.30 cfs and 2.41cfs, respectively (Figure 48). All streams in this water body were dry through September 2014.

Figure 48. Flows at 17040220-08A, 2014.

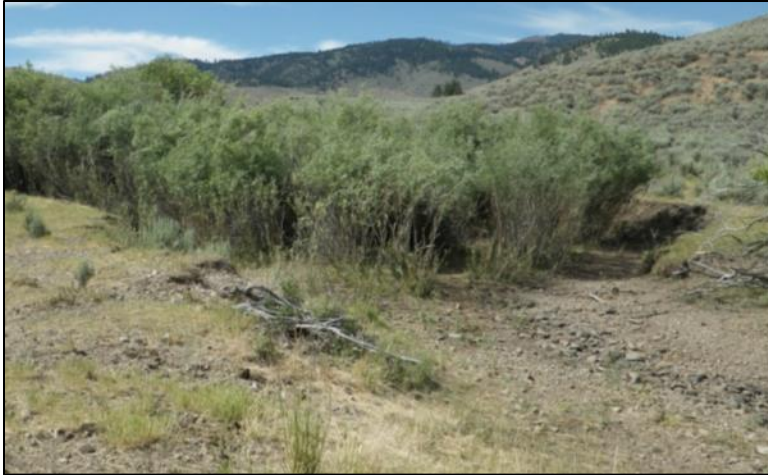
1. All stream segments comprising WBID US-9 are ephemeral.
2. Spring flows are in direct response to snowmelt.
3. The water quality conditions in this water body are currently dictated by the flow regime (Figure 51).

Figure 51. Deer Creek (US-9), 7/08/2014. Ephemeral flow regime in Deer Creek dictates water quality potential.

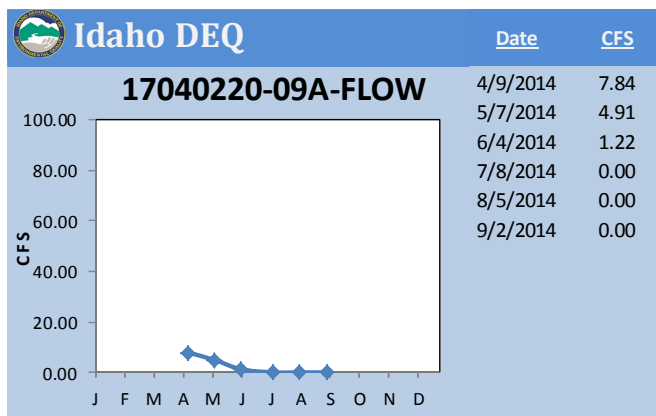
Flows were collected for Deer Creek at sampling location 17040220-09A, approximately 0.75 miles downstream of the confluence of Big Deer Creek and Little Deer Creek. Flows were measured for April, May, and June. A dry channel was observed during the sampling visits in July, August, and September (Figure 52).

Figure 52. Flows at 17040220-09A, 2014.

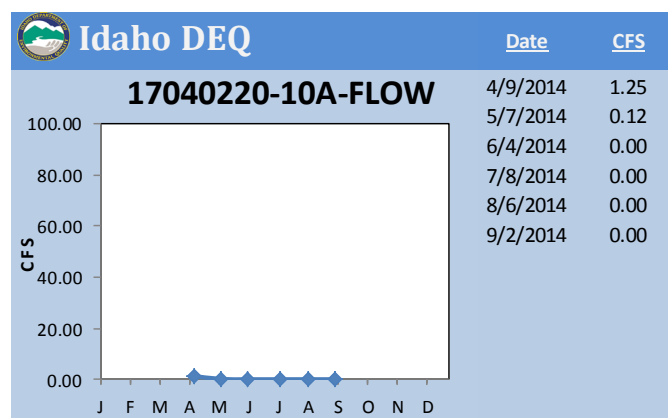
April provided the only measurement of significant discharge at 1.25 cfs (Figure 55). A trace flow of 0.120 cfs was measured in May, with subsequent visits from June through September yielding a dry channel.

Figure 55. Flow at 17040220-10A, 2014.

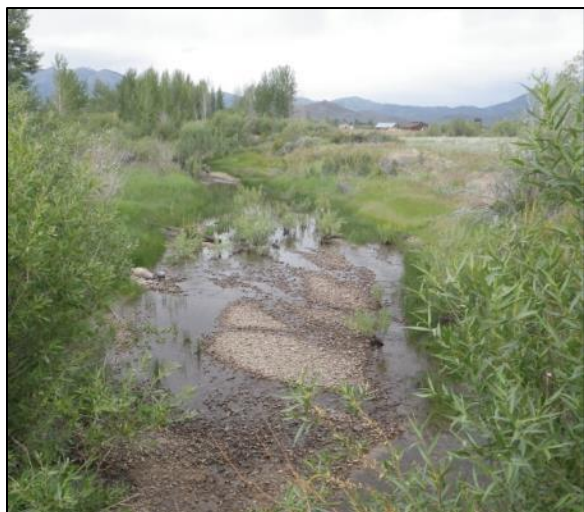
1. ID17040220SK011_02 (Sampson Creek) is ephemeral.
2. ID17040220SK011_03 (Soldier Creek) is perennial until it meets the diversion. Downstream flows are ephemeral, dependent on total flow to the diversion and operation of the diversion for irrigation water delivery.
3. ID17040220SK011_03 exists entirely on the Soldier Creek alluvial fan. This AU is a losing reach; flows infiltrate rapidly to ground water (Figure 58).
4. The Fairfield wastewater treatment facility (NPDES permit ID0024384) is permitted to discharge to Soldier Creek; 100% of the effluent may infiltrate in the tail ditch prior to actually joining the Soldier Creek channel.

Figure 58. Soldier Creek assessment unit ID17040220SK011_03 flows infiltrating, 6/25/2014.

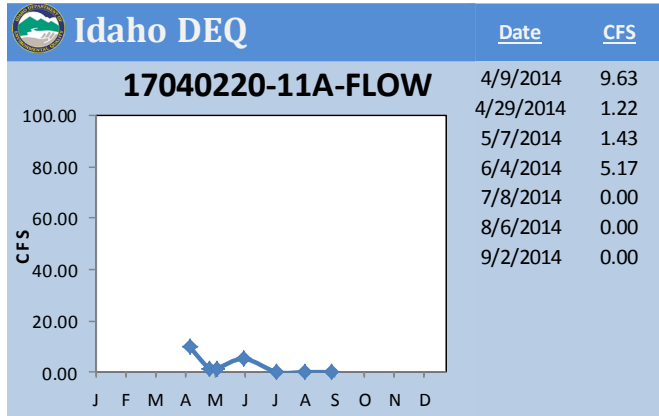
As the flow receded, a second sample point (17040220-11F) was established to assist in understanding the hydrology of Soldier Creek. This sample location was dry after June.

Figure 59. Flows at 17040220-11A, 2014.

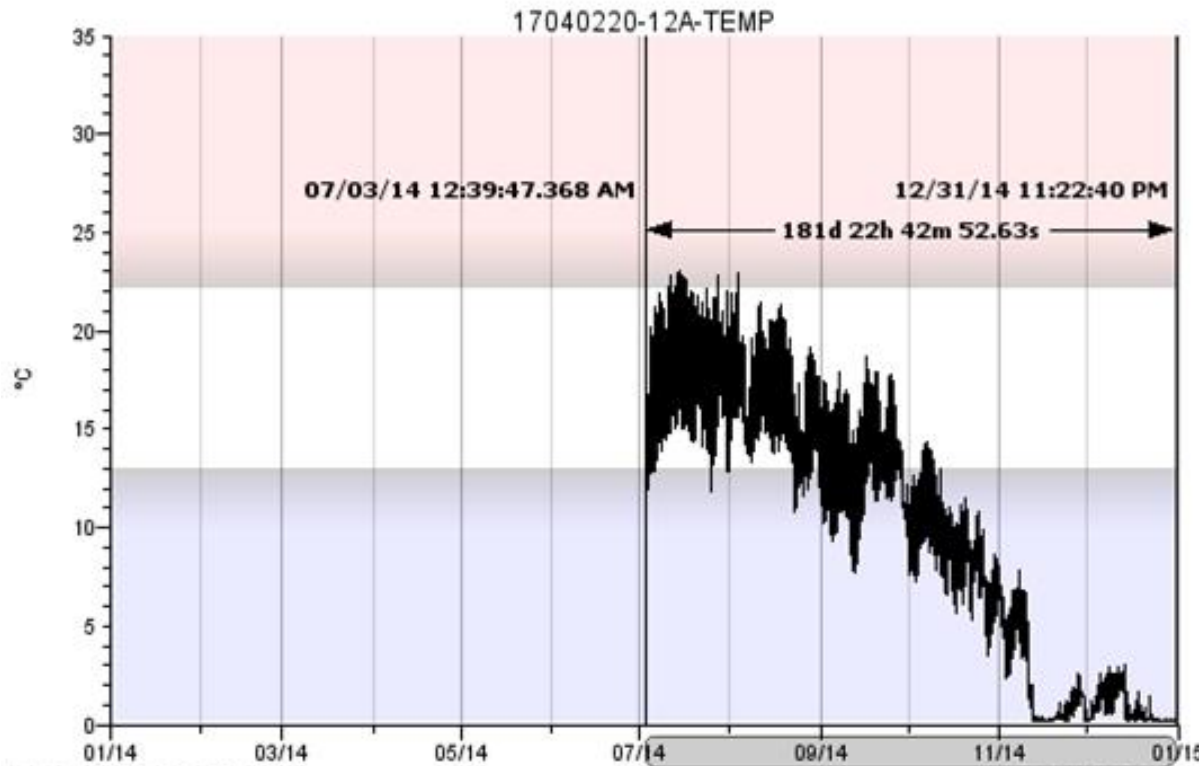
Figure 68. Soldier Creek (US-12) thermograph.

A thermograph was deployed in this water body to capture hourly water temperature measurements. The temperature plot for 7/03/2014–12/31/2014 is displayed in Figure 68. The plot indicates that AU ID17040220SK012_03 has a few exceedances of the instantaneous numeric criteria of 22 °C for the CWAL beneficial use as defined in IDAPA 58.01.02.250.02.b during the measurement period. However, many instantaneous exceedances were seen for the SS beneficial use criteria of 13 °C.

The exceedance analysis of this temperature data set confirmed instantaneous and average criteria exceedances for SS of 100% of measured days in the spring and 48% of measured days in the fall. The exceedance analysis summary is provided in Table 88, and the complete exceedance analysis is included Appendix A.

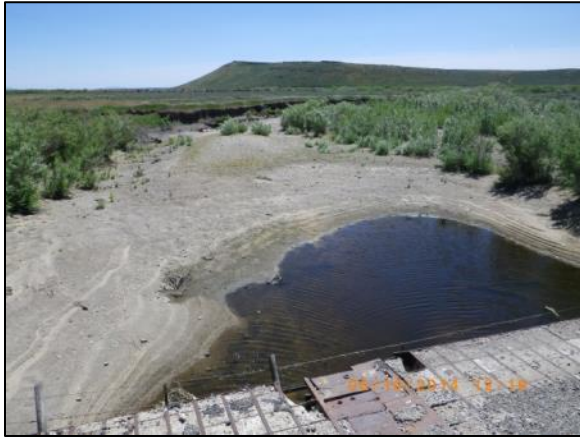
Figure 70. Camas Creek (US-13) 6/10/2014.

Flow, habitat, and use observations during 2014 identified a few notable factors that drive the water quality conditions within WBID US-13 (Figure 70):

1. All stream segments comprising AUs ID17040220SK012_02, _03, and _05 are ephemeral.
2. Reduced flow following spring runoff is a result of losses to ground water.

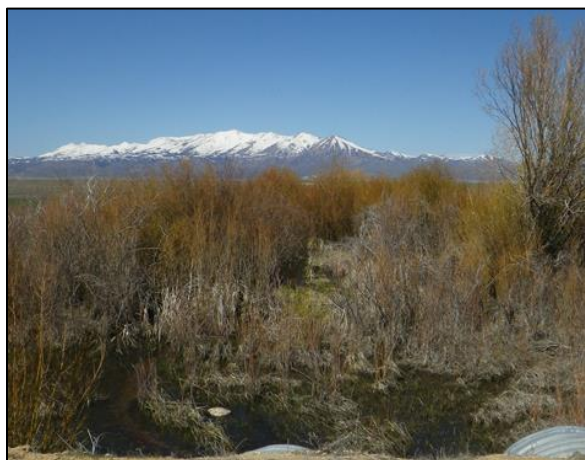
Figure 75. Vegetated channel of Threemile Creek.

1. WBID US-14 is a small basin on the south toe of Smoky Dome mountain with a 2nd-order main channel (Threemile Creek). This heavily vegetated channel connects to Camas Creek southward across the Camas Prairie (Figure 75). The Soldier Mountain Resort and Golf Course is in the upper extent of this drainage.

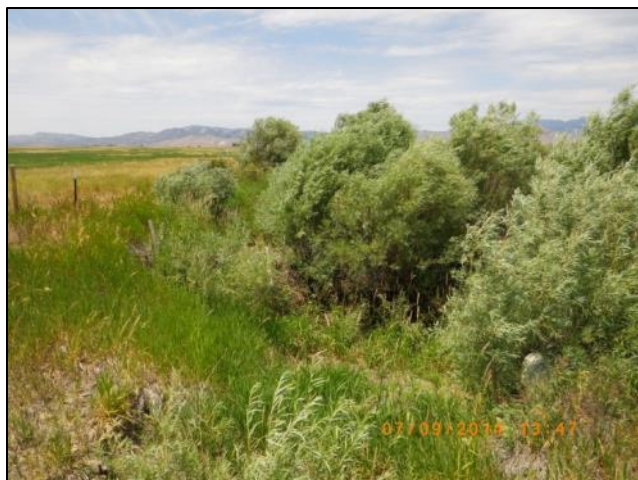
Figure 79. Corral Creek (US-15), 7/09/2014.

1. AU ID17040220SK015_03 is ephemeral (Figure 79).
2. AU ID17040220SK015_03 exists entirely on the Corral Creek alluvial fan. This AU is a losing reach; flows infiltrate rapidly to ground water.
3. Irrigation diversion occurs at the extreme upper end of this AU for use in the surrounding pastures and contributes to the lack of water downstream later in the summer.

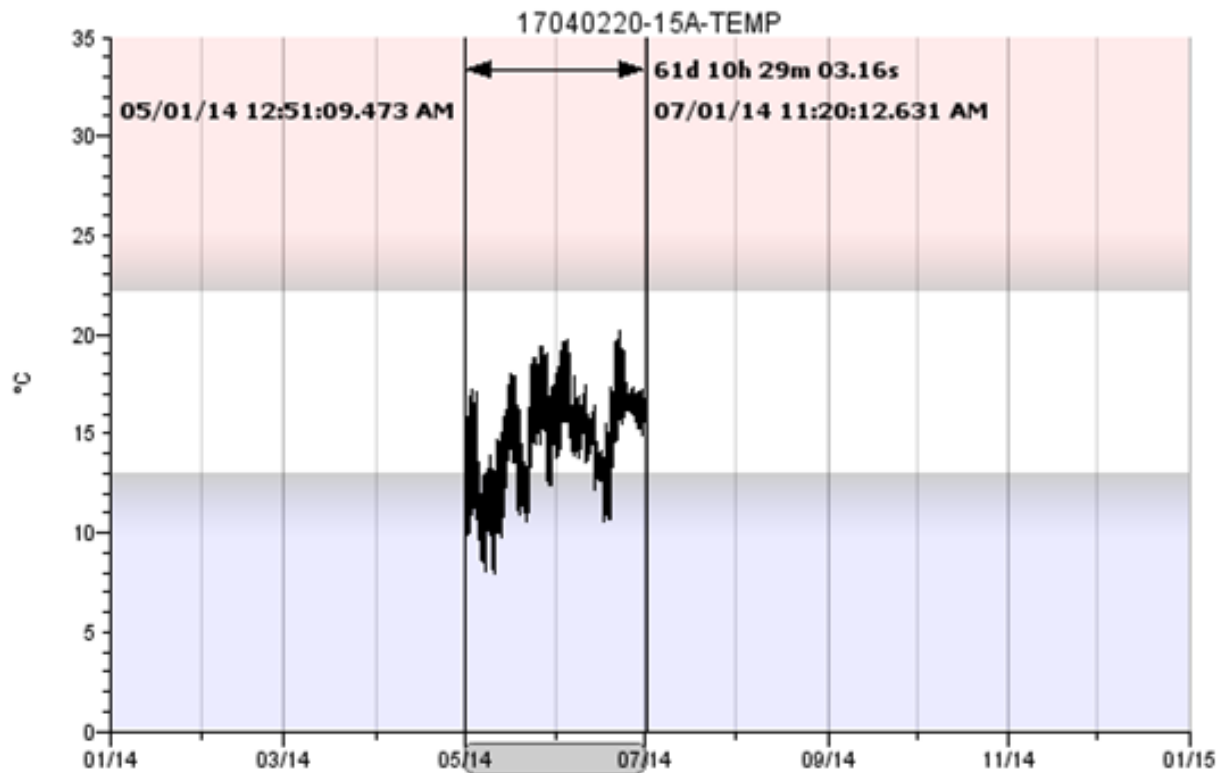
**Figure 82. Corral Creek (US-15) thermograph.**

A thermograph was deployed in this water body to capture hourly water temperature measurements. The temperature plot for 5/01/2014–7/01/2014 is displayed in Figure 82. The plot indicates that AU ID17040220SK015_03 has zero exceedances of the instantaneous numeric criteria of 22 °C for the CWAL beneficial use as defined in IDAPA 58.01.02.250.02.b during the measurement period.

An exceedance analysis of the 17040220-15A temperature data set was completed. There were no exceedances of the instantaneous temperature criteria or daily average temperature criteria for CWAL.

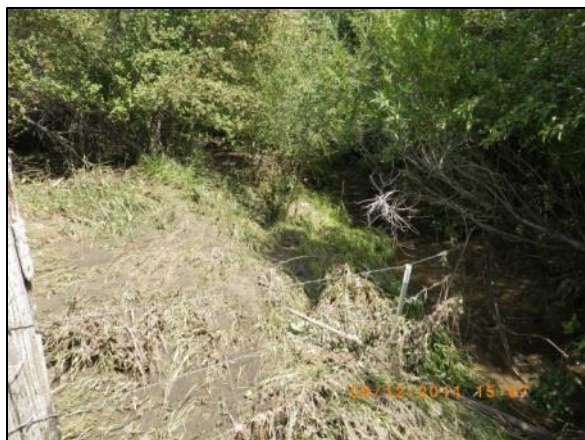
Figure 84. East Fork Corral Creek (US-16)—evidence of out-of-bank flood event including sediment deposition, 8/12/2014.

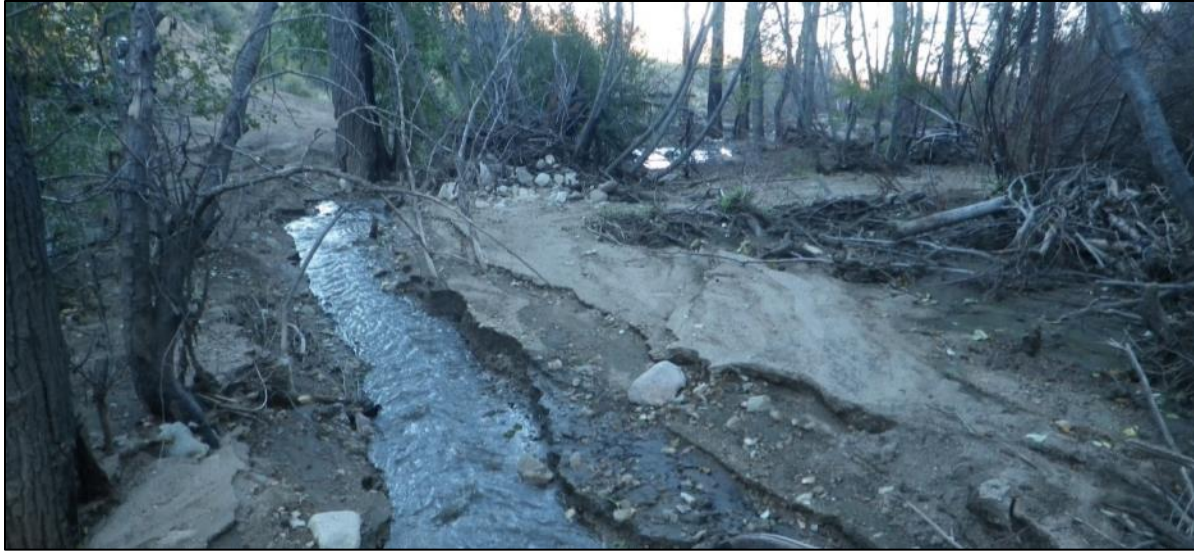
Figure 88. West Fork Corral Creek (US-17)—natural channel restructuring following debris flow, 9/03/2014.

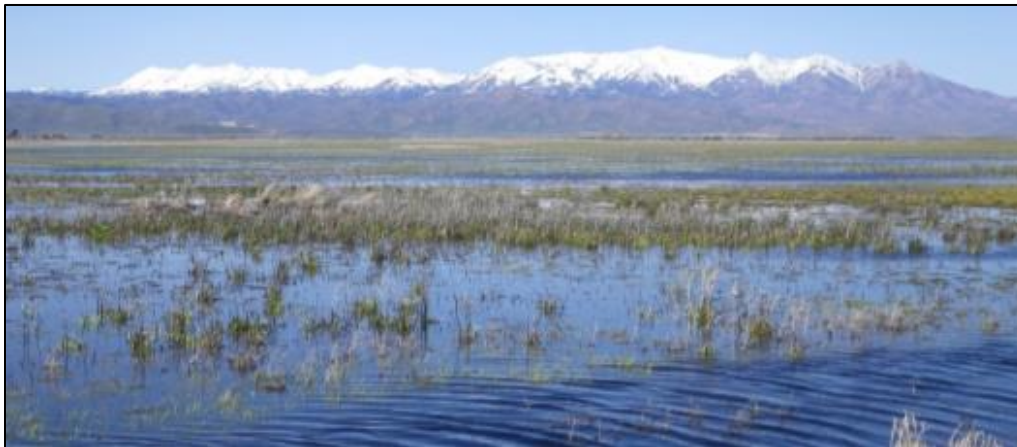
2. The Centennial Marsh collects all waters in US-18. This complex provides natural filtering of surface waters moving through this system. The 3,100-acre wetland complex is owned by the State of Idaho and managed by the Idaho Department of Fish and Game (Figure 92).

Figure 92. Centennial Marsh, 4/29/2014.

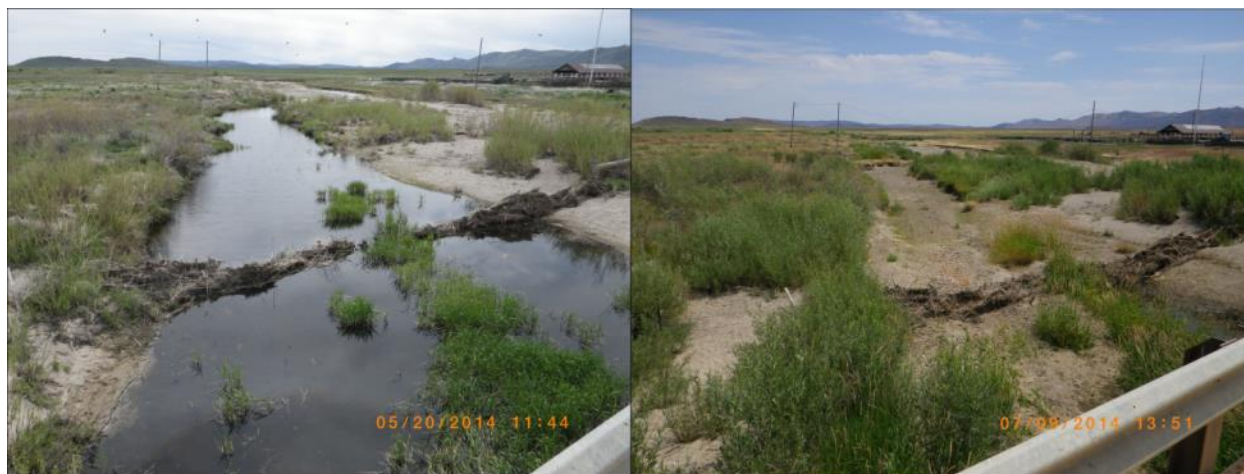
Sample site 17040220-18A was located at the WBID US-18 pour point to describe surface water quality being discharge downstream (Figure 95).

Figure 95. Sample site 17040220-18A, 5/20/2014 and 7/09/2014.

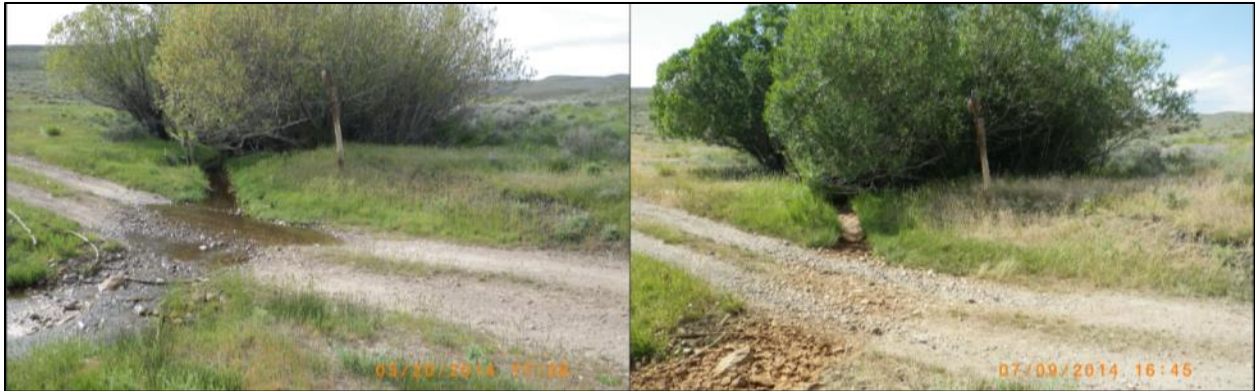
Figure 96. Sample site 17040220-18F, 5/20/2014 and 7/09/2014.

Cow Creek above the reservoir is significantly incised to depths up to 12 feet. Large woody vegetation now inhabits this channel. The current willow and aspen community appears to be at least 25 years old, is well rooted, and is exhibiting new-growth recruitment. The historical conditions or land-uses that contributed to the channel incision appear to have ceased.

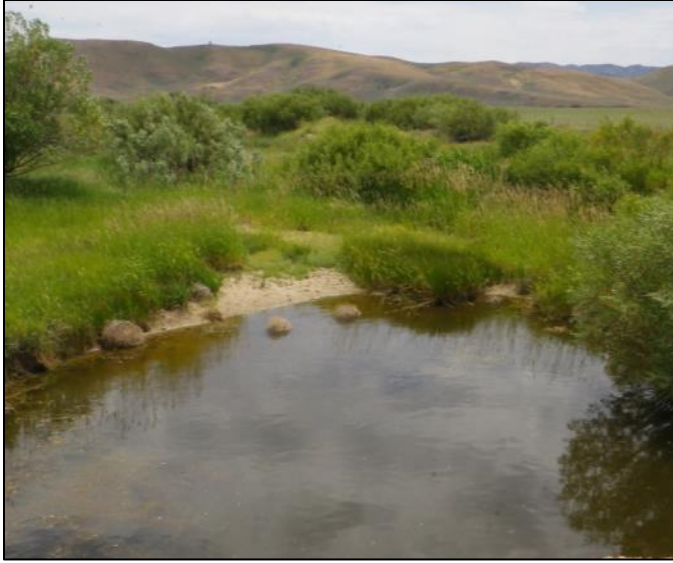
4. The mid-channel areas of ID17040220SK019_04 appear to be used for irrigation conveyance and withdrawal as indicated by the presence of pumps and ponds.
5. The lower extent of ID17040220SK019_04 interfaces with a shallow water table, providing surface expression of the ground water throughout the year. Although the main channel is dry, pool areas remain full at water-table level (Figure 98).

Figure 98. Chimney Creek perennial pool in dry channel.

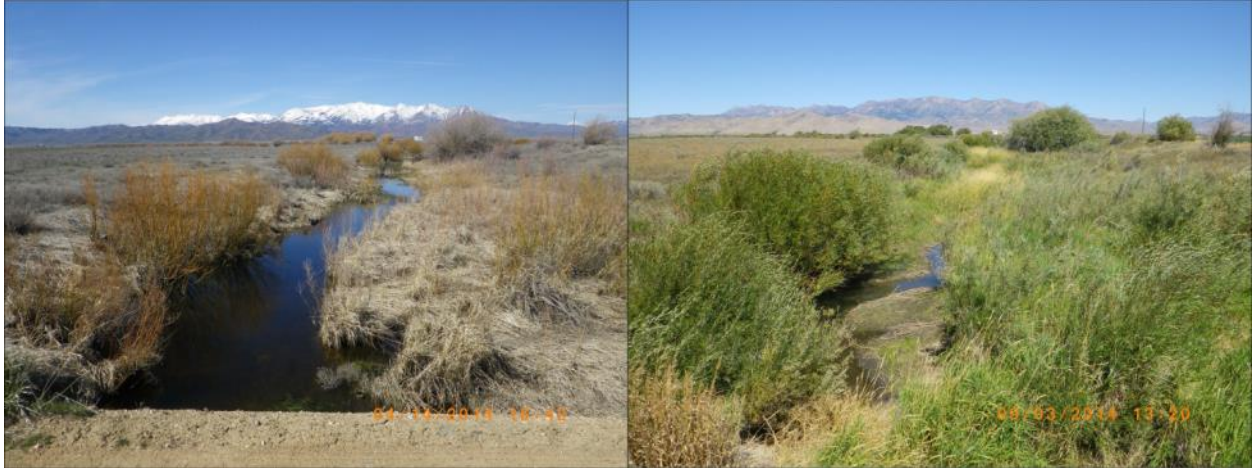
DEQ sampled this water body from April 2014 through September 2014 (Figure 100). These efforts included composite grab samples for lab analysis of ammonia, TKN, TN, TP, TSS, and *E. coli*. When possible, flows were measured to allow for instantaneous pollutant load calculations (Table 134). As sampling locations presented no-flow or dry conditions, new locations were established upstream.

Figure 100. Sample site 17040220-19A, 4/14/2014 and 9/03/2014.
